MIYAGI, Toyohiko. Necessity of new paradigm for conquest the millennium / compound class disaster. The Tenth International Symposium on Mitigation of Geo- disasters in Asia : Sendai-Bandai-Kamikochi-Kyoto-Matsue, Japan 2012: 6-16

## **Necessity of new paradigm for conquest the millennium / compound class disaster**

***Toyohiko MIYAGI (Tohoku-Gakuin University, Sendai, Japan)***

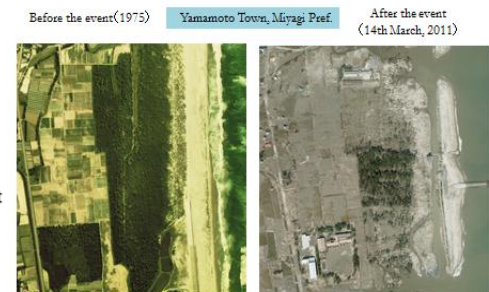
## Field evidence: forest made mitigate tsunami energy

森林が津波浸水深を低減させた可能性

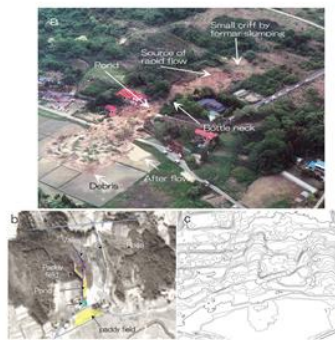
Rapid flow landslide at the artificial reclaimed area by the trigger of earthquake on May 26, 2003 Miyagi Prefecture.

- a: An overview of landslide area just after the disaster.
- b: The landslide occurred at the reclaimed small valley. The land modification completed 35 yrs ago for agricultural use. The former topography and land cover such as pond and paddy field shows highly potential of ground water.
- c: The 1 meter contour map shows the clear landslide topography.

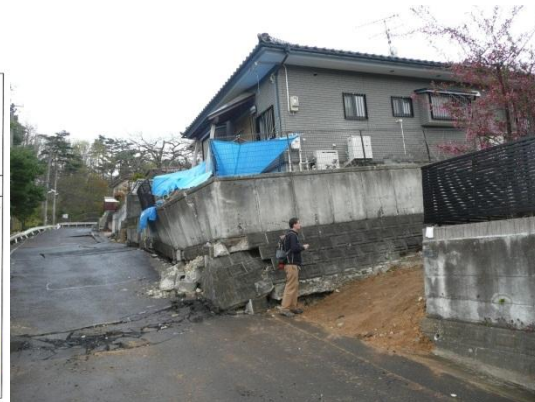
Typical view of the land deformation.
